**FIRE SAFETY INSPECTION REPORT**

<b>Occupant Name:</b>	Heron Pond	<b>Inspection Date:</b>	1/19/2023
<b>Address:</b>	241 Southwest 84 Avenue	<b>Inspected By:</b>	Victor Santos
<b>Suite:</b>	Bldg. - #18	<b>Property Use Type:</b>	Multifamily dwelling
<b>Occupant Number:</b>		<b>InspectionType:</b>	Annual Fire Alarm (FAS), Annual Fire and Life Safety Inspection
<b>Occ. Sq. Ft.:</b>	20000	<b>Number of AEDs:</b>	0

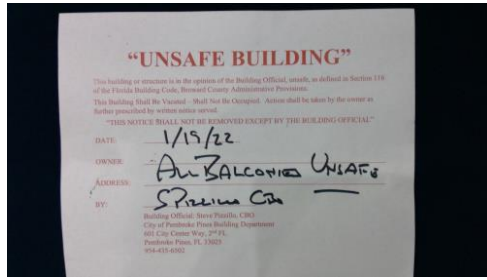
1.1 - 10.1.4.1.

<b>Deficiency</b>		FL NFPA 01 2018 Chapter 10 General Safety Requirements	10.1.4.1 - Excerpt: Where structural elements have visible damage, the AHJ shall... (see photo 1.1)
-------------------	--	---	---

**Inspector Comments:** \*\*\*The noted structural damages have been referred to the City's Building Official and Structural Chief for evaluation of possible unsafe conditions. A site visit with structural inspectors and the Building Official to demonstrate areas of concern was conducted. Following the site visit, an structural engineer was consulted and in conjunction with the Building Official, deemed each patio/balcony area unsafe. The Building Official instructed Xochitl Alvarez, the property manager, to produce an analysis and proposal completed by a structural engineer for conditions and repairs within 48 hours. Each building and unit had an "Unsafe Building" notice posted on the front door as well as verbally communicated with residents who were home at the time. Residents were instructed that due to the unsafe conditions, they are to remain clear of the patio/balcony area until further notice is given.\*\*\*

Where structural elements have visible damage, the AHJ shall be permitted to require a technical analysis prepared in accordance with Section 1.15 to determine if repairs are necessary to restore structural integrity.
